RESERVE FUND STUDY UPDATE WITH SITE VISIT
OTTAWA-CARLETON STANDARD CONDOMINIUM CORPORATION No. 769
OTTAWA, ONTARIO

File # 18377
March 12, 2019

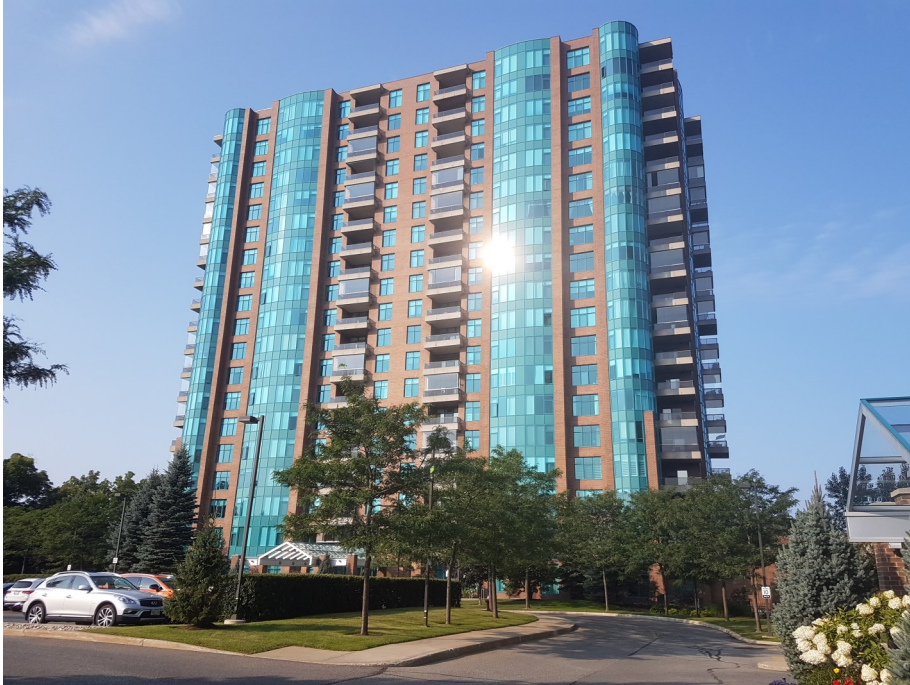
1. Partial front elevation of OCSCC 769

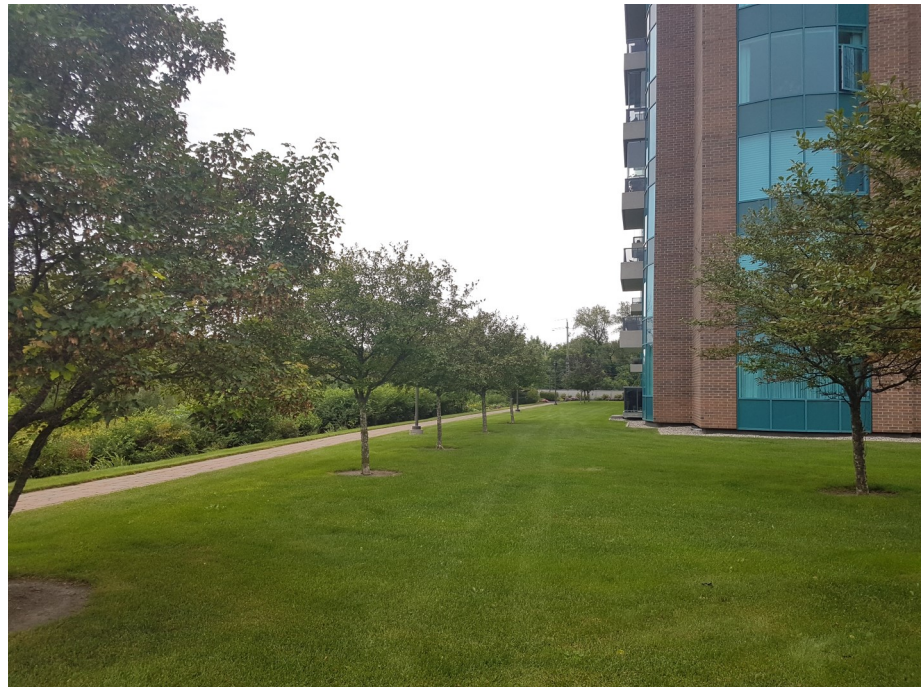
2. General view of the landscaped podium.

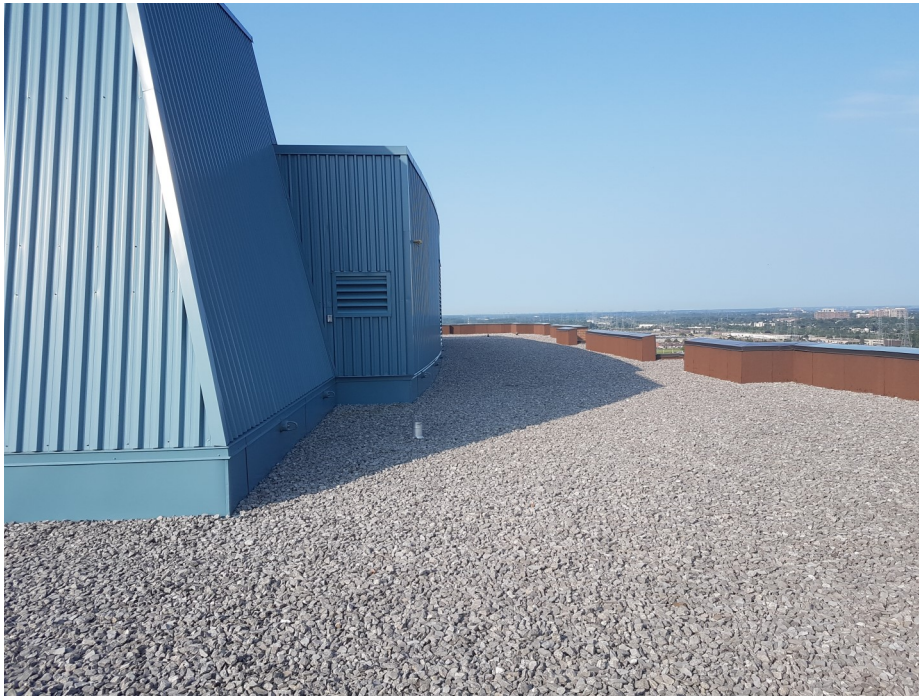
3. General view of inverted roofing system and the mechanical penthouse aluminium siding

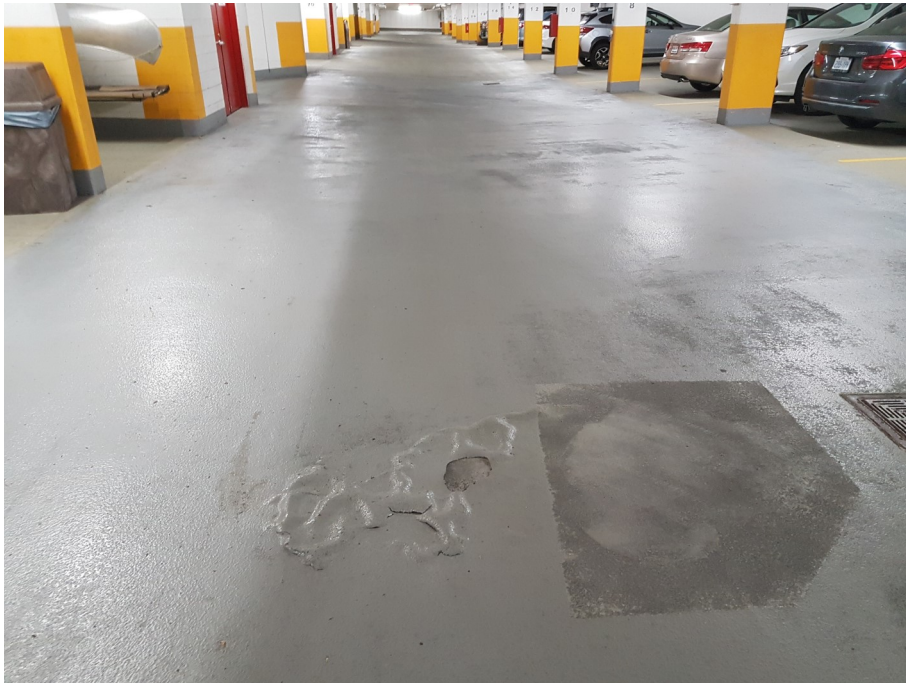
The traffic bearing membrane at the turning radiuses, ramp and garage entrance on Level P1 is suspected to have been patched over the life of the condominium. The traffic bearing membrane is in fair-to-poor condition with areas of membrane delamination observed at the garage entrance, the base of the ramp and intermediate slab drains. The traffic bearing membrane at the turning radiuses, garage entrance and ramp has reached the end of its useful service life and should be replaced in the near future.

4. Showing traffic bearing membrane delamination and previous repairs within the parking garage

- .F Replacement of the traffic bearing membrane at the drive lanes and parking areas on level P1 is estimated to cost **\$260,000** and this work has been budgeted in **2026 and every 20 years** thereafter
- .G According to the information provided, replacement of the traffic bearing membrane at the turning radiuses and ramps has been scheduled in the fall of 2018. This work is estimated to cost **\$40,000**
- .H In order to ensure funds are available to perform isolated repairs to the intermediate slab and traffic bearing membranes when required, an allowance of **\$10,000** has been budgeted in fiscal year **2021 and every 5 years** thereafter
- .I Minor repairs of the traffic bearing membrane should be performed, as required, using funds from the operating budget

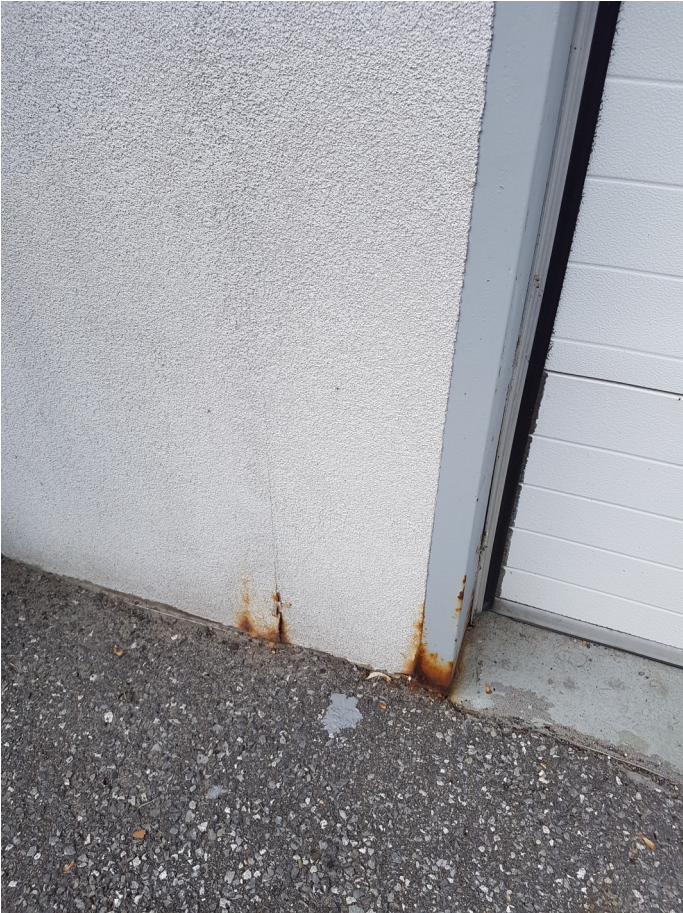
5. Showing localized garage door frame corrosion and cracking of the garage entrance EIFS

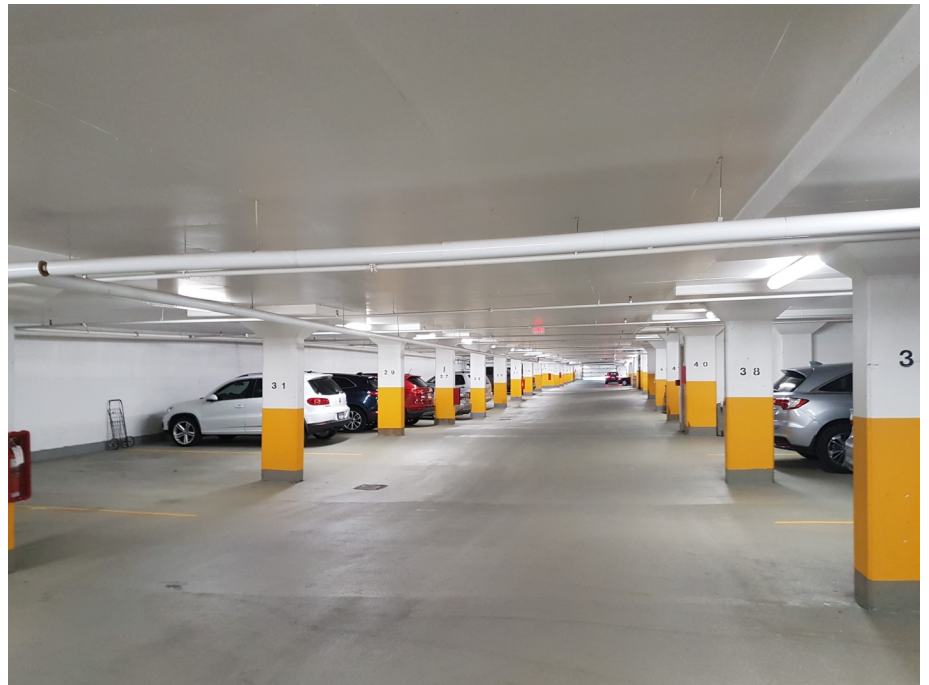
6. General view of the parking garage

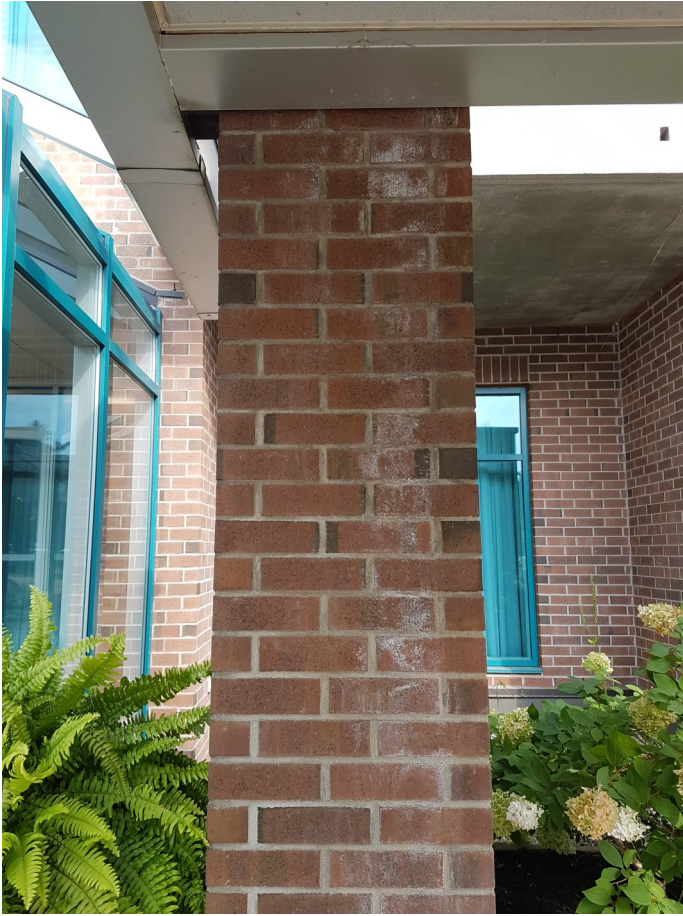
7. Showing localized masonry efflorescence at the entrance canopy columns

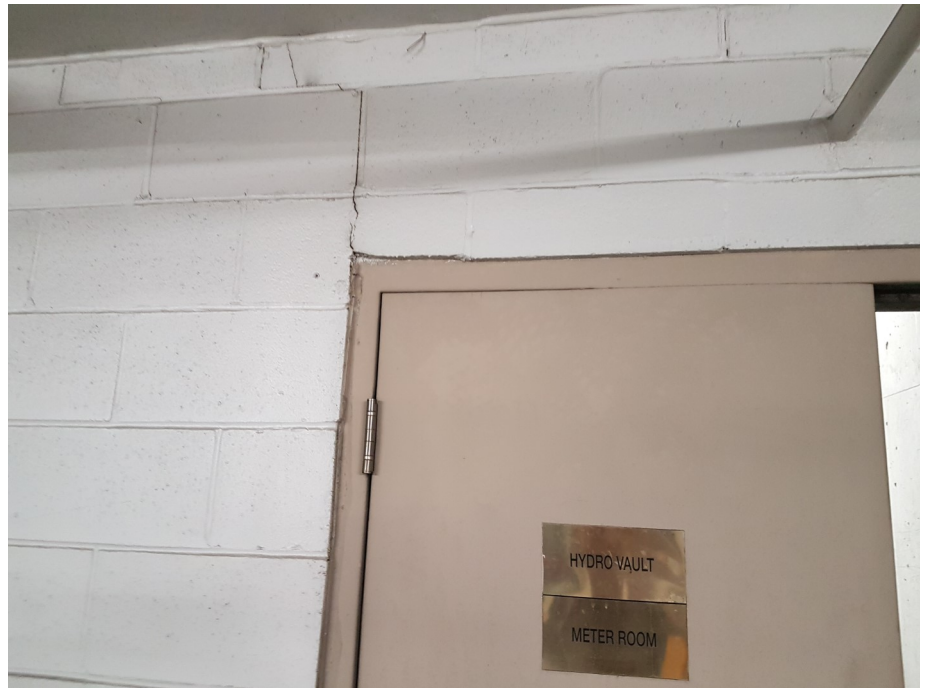
8. Showing localized concrete block masonry step cracking within the parking garage

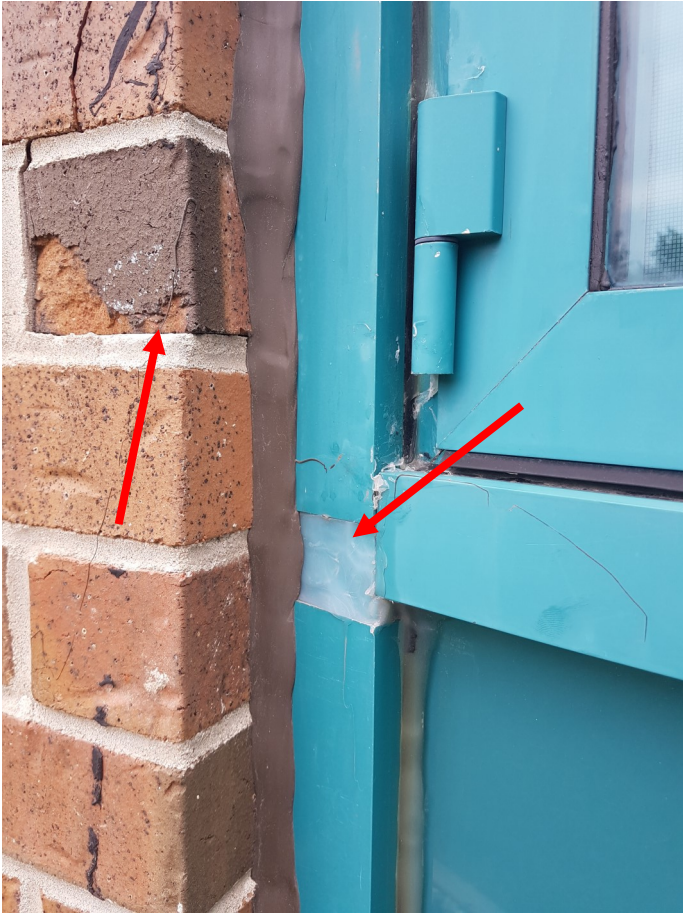
9. Showing punched widow frame silicone sealant repairs and localized masonry veneer delamination

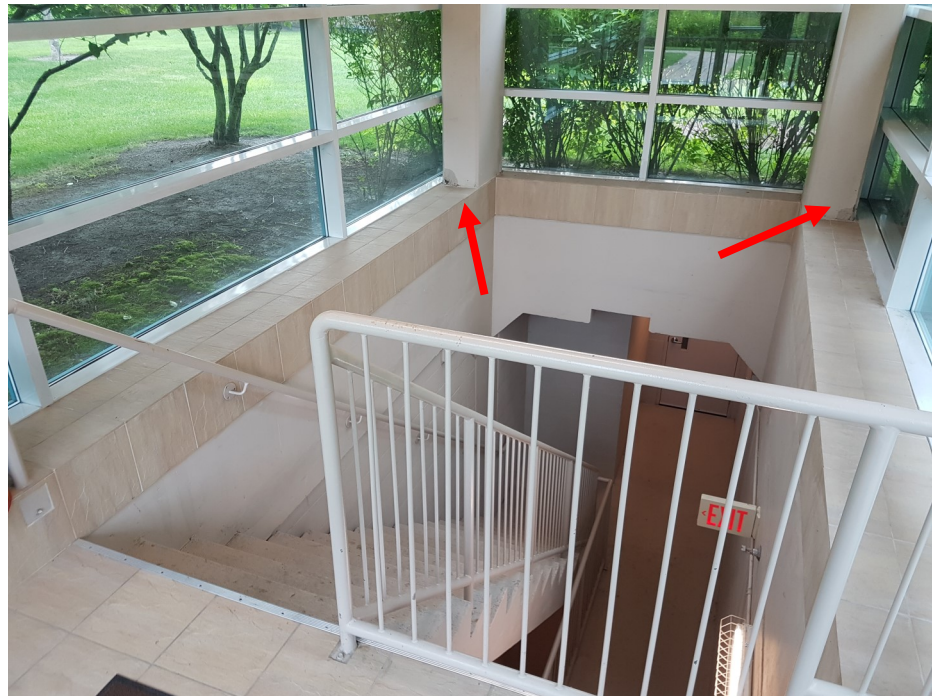
10. Showing condition of podium stairs with localized concrete column delamination

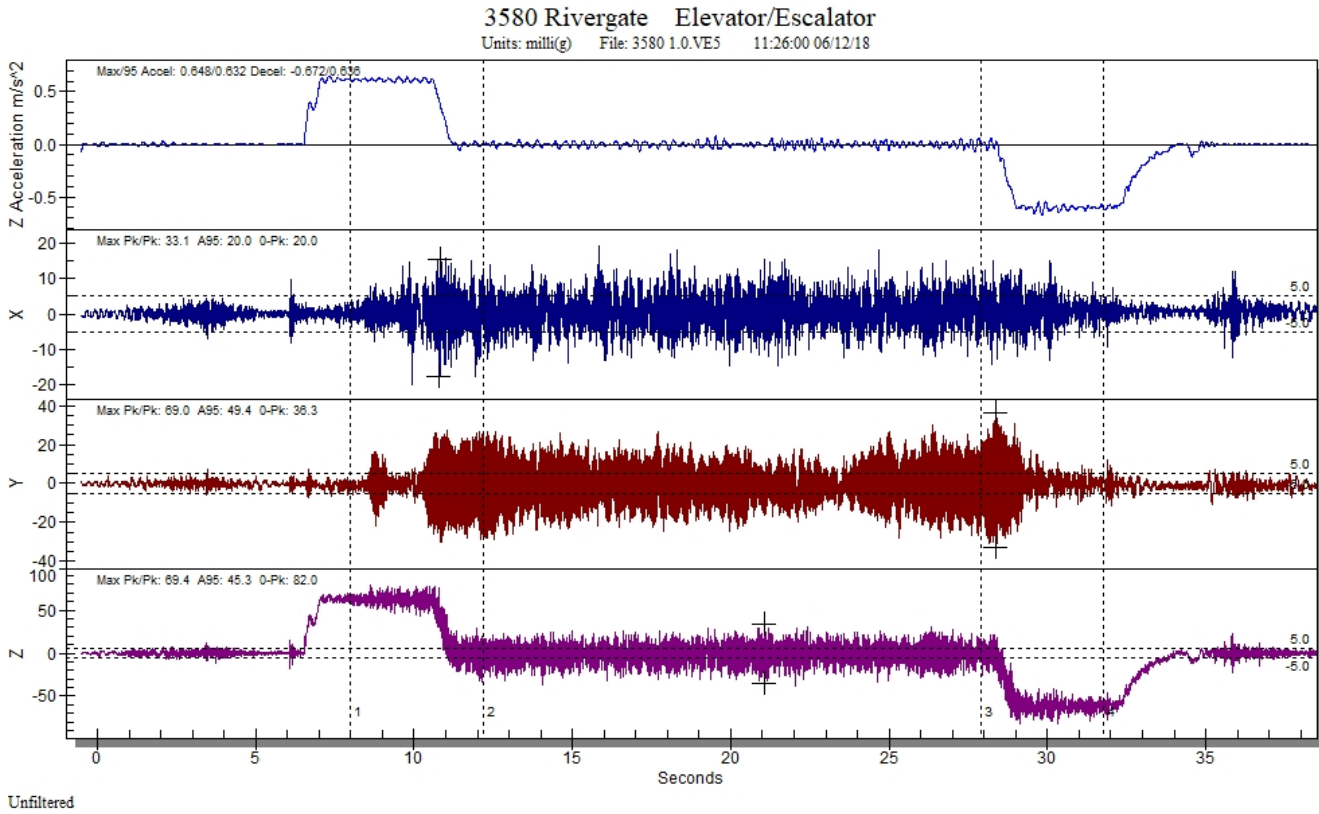
Passenger 1-2 - 1

The ride quality appears to be poor in the X, Y and Z axes. The readings are greater than the suggested value and should be improved. The contractor should review the ride quality in all axes and make the necessary adjustment or repairs to rollers, rails, stabilizers, etc. as required.

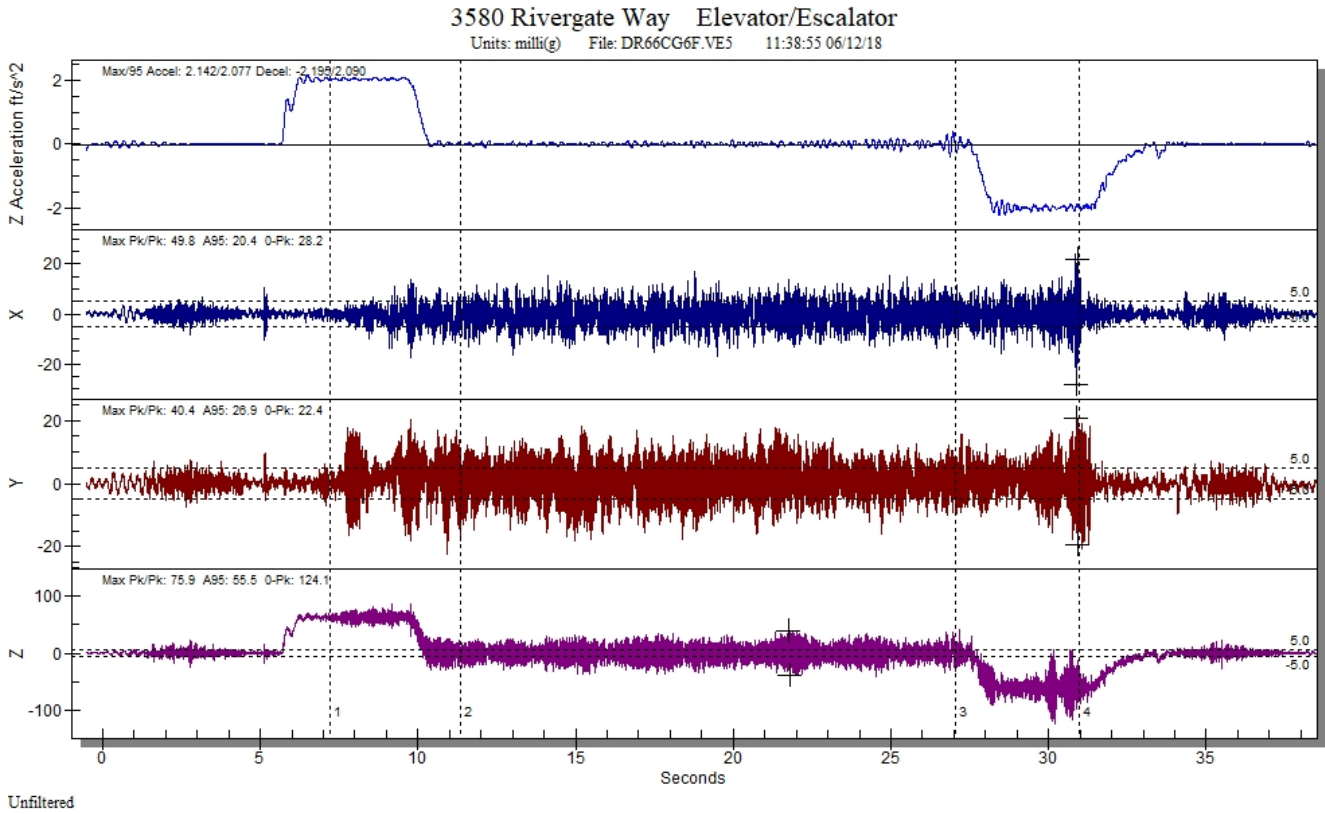
Passenger 1-2 - 2

The ride quality appears to be poor in the X, Y and Z axes. The readings are greater than the suggested value and should be improved. The contractor should review the ride quality in all axes and make the necessary adjustment or repairs to rollers, rails, stabilizers, etc. as required.

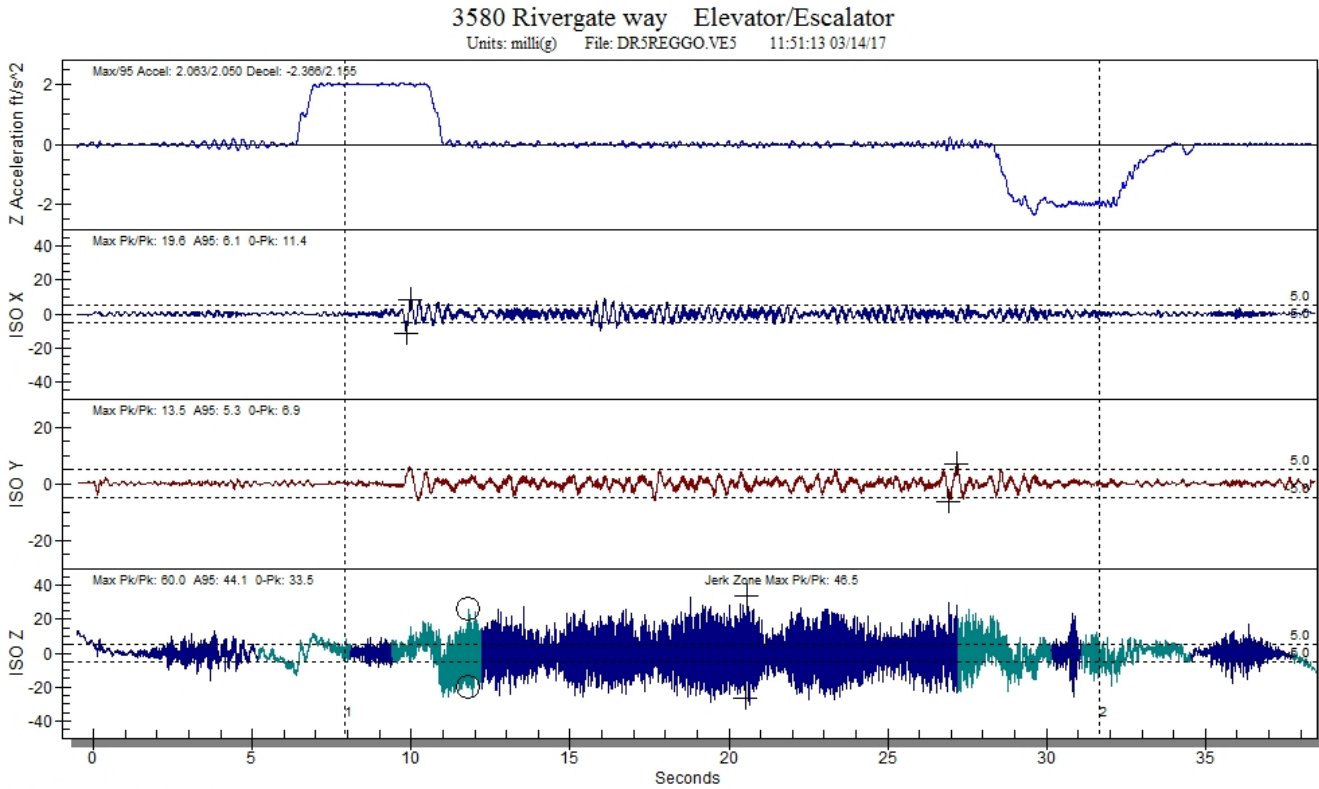
Passenger 3-4 - 3

The ride quality appears to be poor in the X and Z axes. The readings are greater than the suggested value and should be improved. The contractor should review the ride quality in those axes and make the necessary adjustment or repairs to rollers, rails, stabilizers, etc. as required.

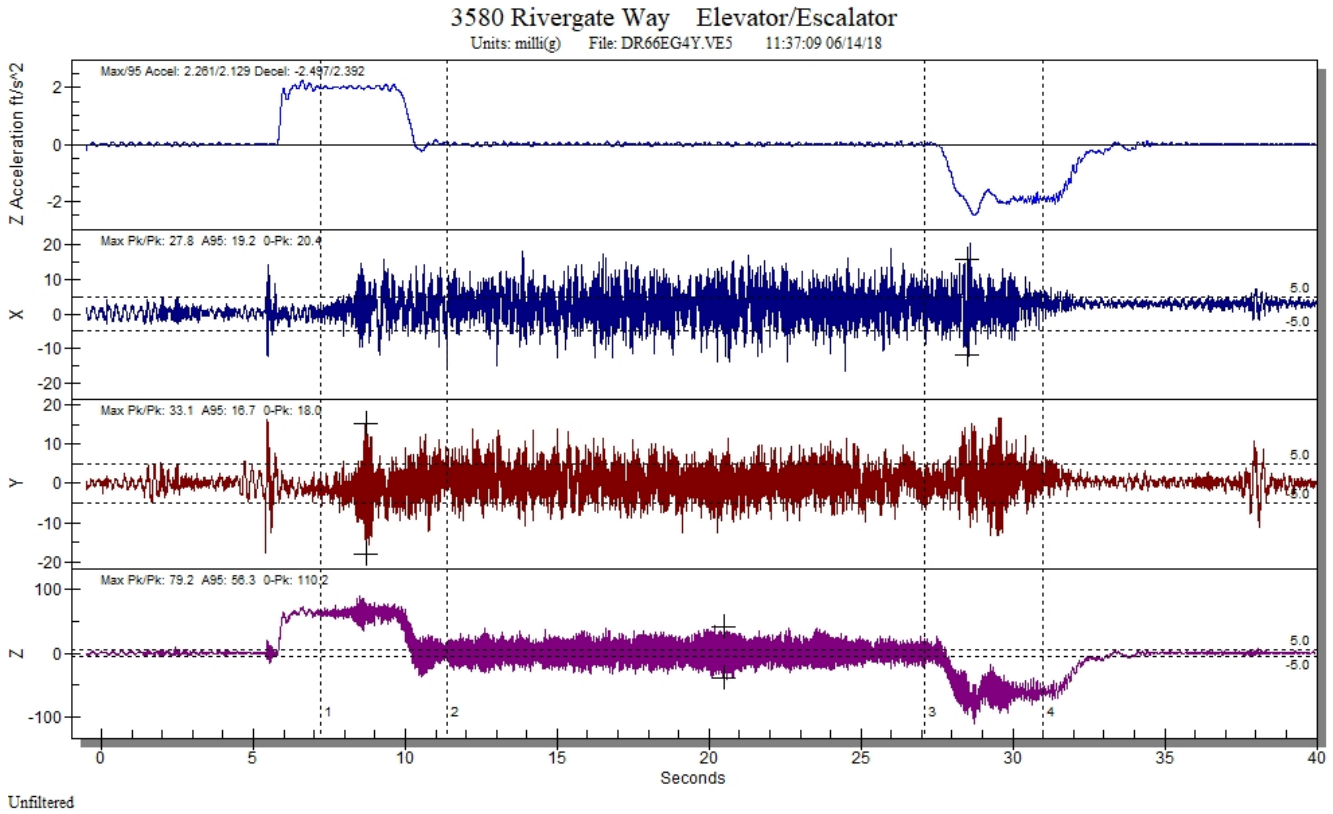
Passenger 3-4 - 4

The ride quality appears to be poor in the X, Y and Z axes. The readings are greater than the suggested value and should be improved. The contractor should review the ride quality in all axes and make the necessary adjustment or repairs to rollers, rails, stabilizers, etc. as required.
