## **Comprehensive Reserve Fund Study**

**Ottawa-Carleton Standard  
Condominium Corporation No. 769**

August 12, 2009

Job No. L1521

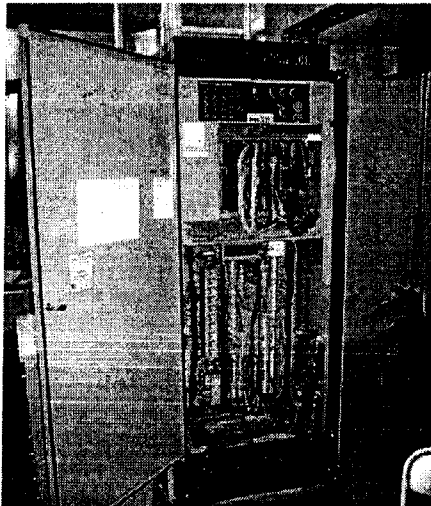
**ThyssenKrupp Elevator  
TAC 50 Controller**

The elevator machine rooms were cool at the time of our inspection. There appears to be sufficient cooling in each elevator machine room.

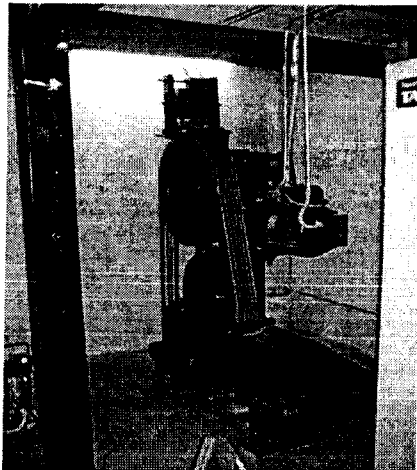
**ThyssenKrupp Elevator  
GD-1 Geared Machine**

The geared machines are equipped with a double brake which provides for UP overspeed and Uncontrolled movement of the car and counterweight.

With all identified deficiencies corrected in an acceptable manner, and with proper preventive maintenance being carried out on the drive equipment in the future, it should provide acceptable service for another fifteen to twenty years, as long as replacement components are available.

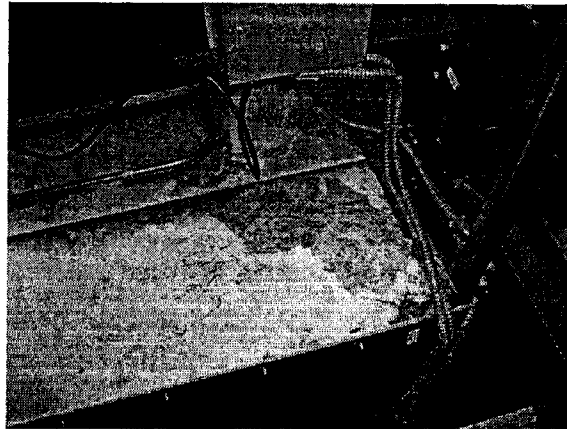
The hoistways and car tops are relatively dirty and dusty from construction in the building. There are used elevator parts, rags and debris on most of the car tops.

**Dusty Car Top with Rags**

We have noted these deficiencies in the report and all should be corrected by ThyssenKrupp Elevator.

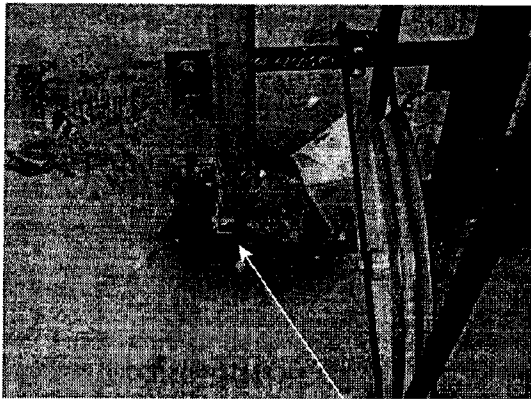
**Counterweight Rail  
Resting on Buffer Channel in Pit**

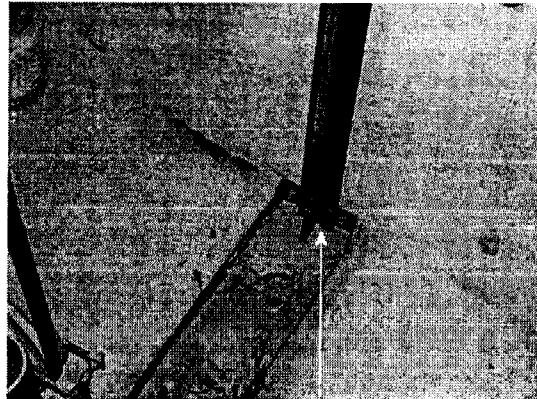
**Main Rail  
Resting on Buffer Channel in Pit**

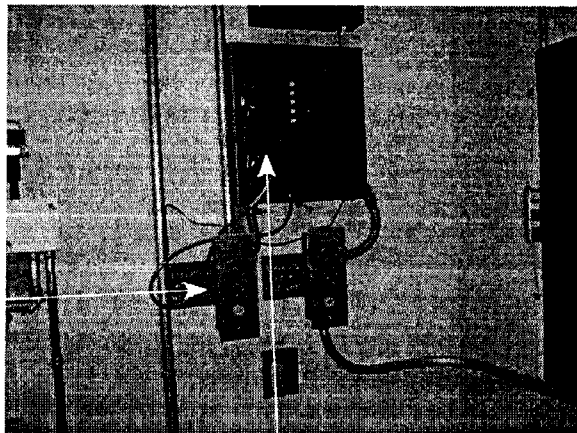
**Building Elevator Communication System**

The B44-00 Code states that the additional two-position fire recall switch when required shall be located at the fire control panel only (Clause 2.27.3.1.2). Our site inspection confirms that the required two position key switch for each group of elevators **HAS** been provided in the fire control panel room. Also, the required building communication system to call into the elevators has also been installed in this room.
