COMPREHENSIVE RESERVE FUND STUDY

*Ottawa-Carleton Standard
Condominium Corporation No. 769
3580 Rivergate Way, Ottawa, ON*

Final Report

BLP File No. 7302.09
January 18, 2016

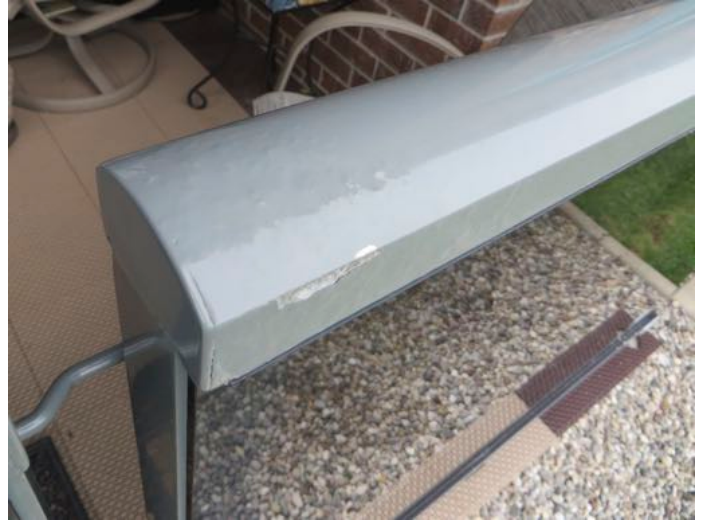
Photo 2
Example of bubbling paint on a pre-finished aluminum guardrail.

Typically, the manufacturer applied finish should last 20-30 years. A cost to prepare and paint all balcony railings has been included later in the study. This cost may have to be moved up in later studies, depending on the condition. Minor repairs and occasional paint touch ups should be done using funds from the operating budget.

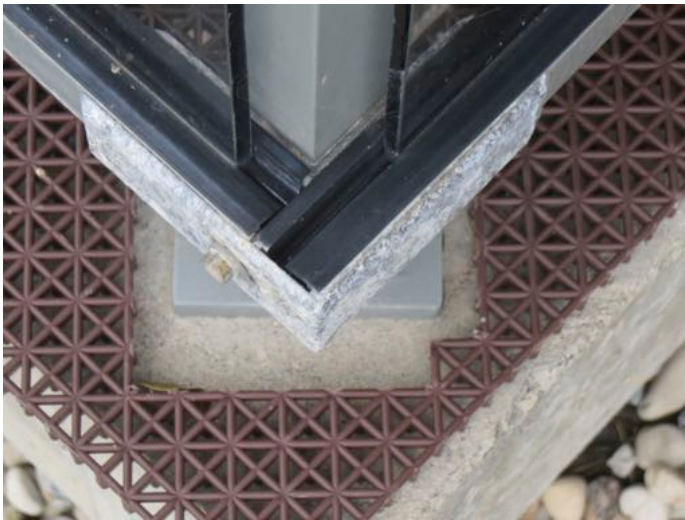
Photo 3
Example of balcony guardrail missing paint due to corrosion.

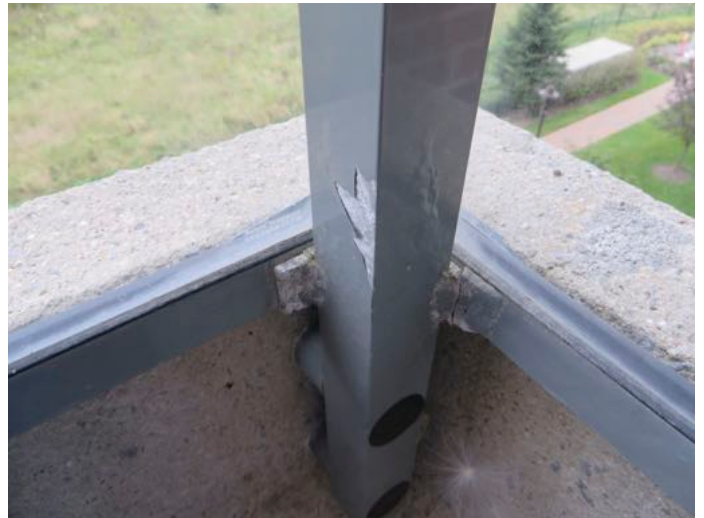
Photo 4
Balcony guardrail example showing peeling paint, corrosion and a cracked member.

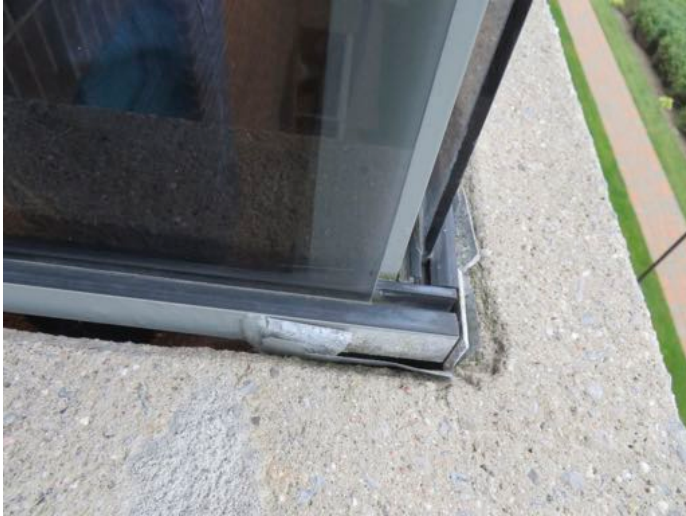
Photo 5

The guardrail bracket appears to be corroded and cracked, at Unit 505.

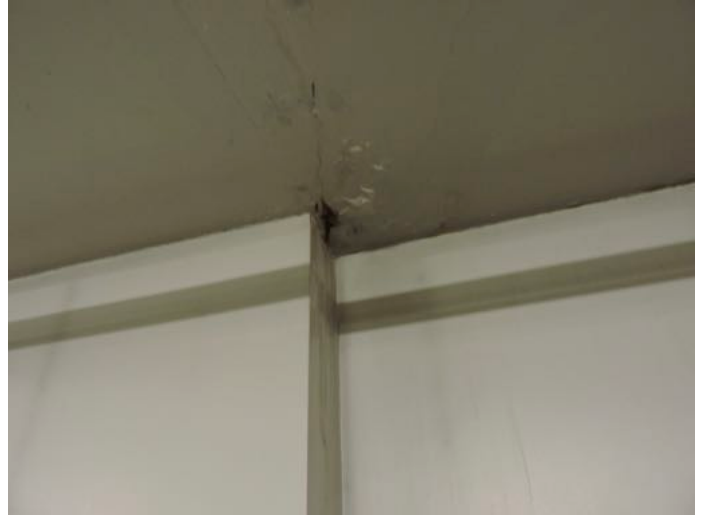
Photo 6

Example of water damage on the ceiling on level P1, Spot 54.

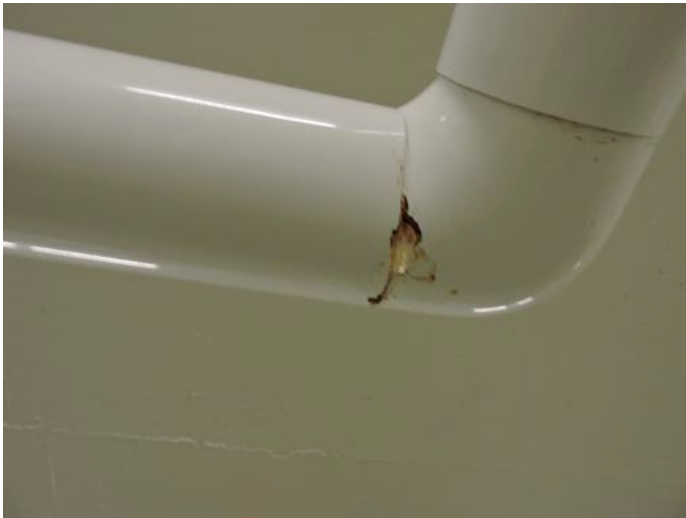
Photo 7

Water leak in overhead insulated pipe on level P1, near Spot 68.

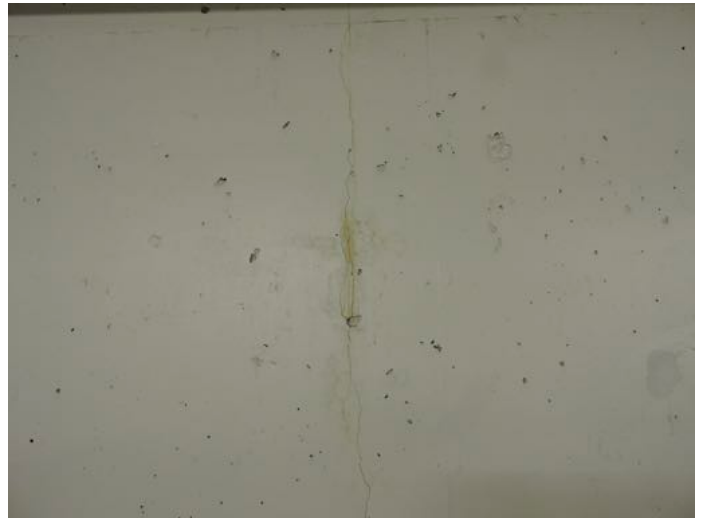
Photo 8

Vertical cracks were observed in the parking garage at various locations. These cracks appear to be shrinkage cracks, which are normal for concrete structures, however several of the cracks show signs of water leakage. The following issues were observed:

Example of cracking with possible water penetration on P1 level, Spot 21.

All of the sources of the water leakage (around exhaust fans and along the walls) should be investigated and repaired.

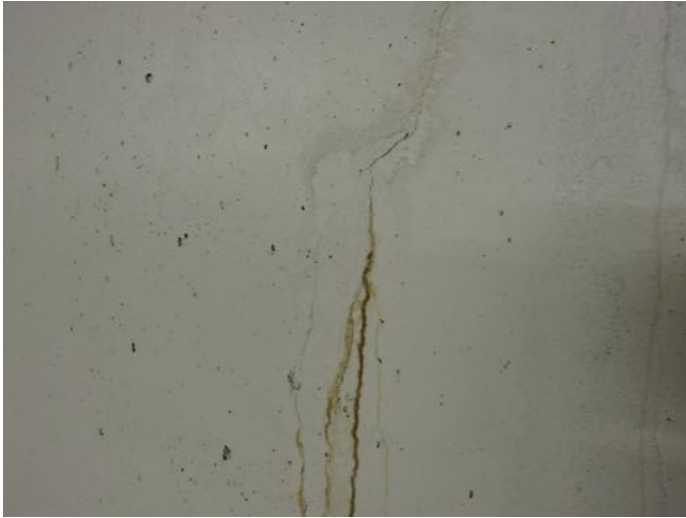
Photo 9

- P2 Spot 106 – vertical crack and water penetration through the parking lot wall.

Example of a vertical crack and water penetration through the parking lot wall on level P2, at Spot 106.

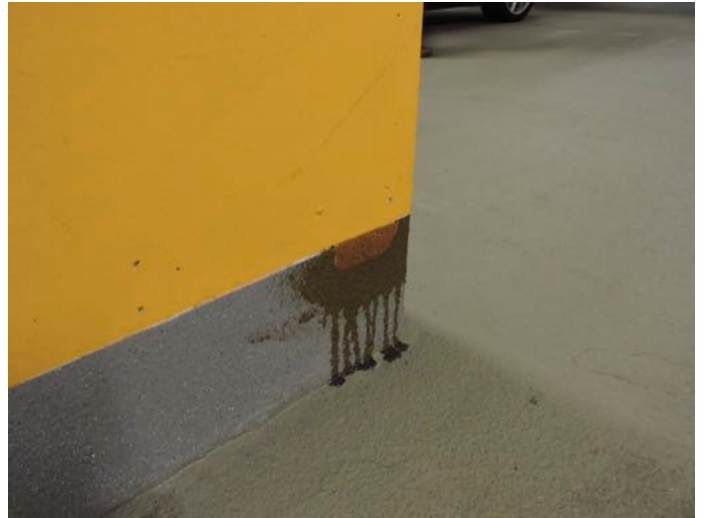
Photo 10

Example of unknown brown staining on a parking garage column, P1 level Spot 20.

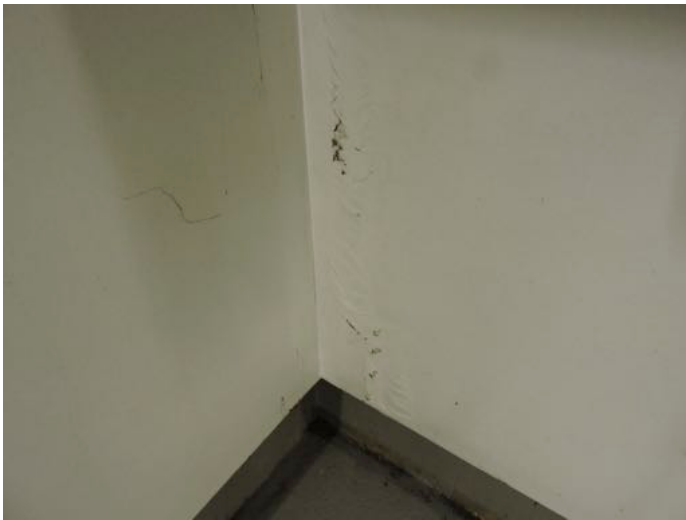
Photo 11

On level P1, under fan EF-4 some water damage is visible.

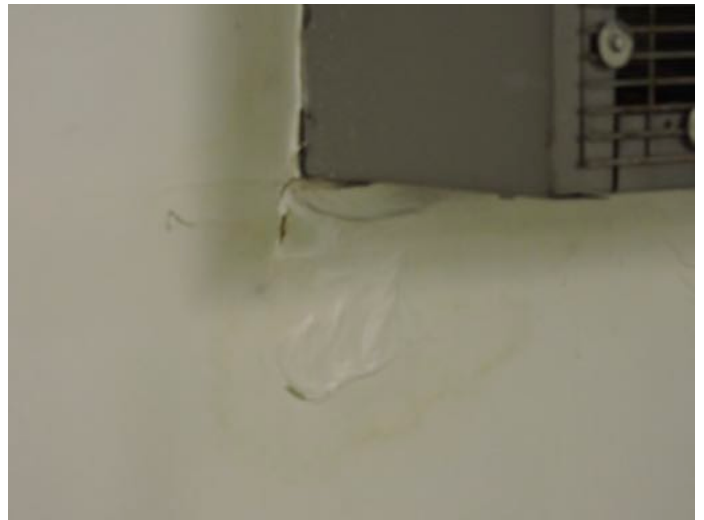
Photo 12

On P1 level, under fan EF-5 some water damage is visible.

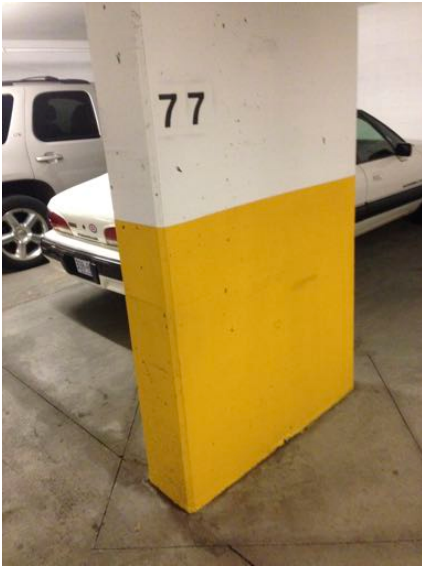
Photo 13

Caulking is applied around the entire concrete columns-to-concrete slab on grade transitions. The caulking is generally in good condition at this time, but should be reviewed regularly. Caulking was noted to be missing from multiple columns on the P2 level. This caulking helps keep excessive water from draining or pooling directly against the concrete columns. This will help prevent premature deterioration of the concrete columns, which typically occur due to excessive wetting during the winter months. The road salts carried into the garage by the vehicles deteriorates the concrete and steel reinforcement. A cost to replace the caulking is included in this study.

Example of missing caulking around the bottom of parking garage columns.

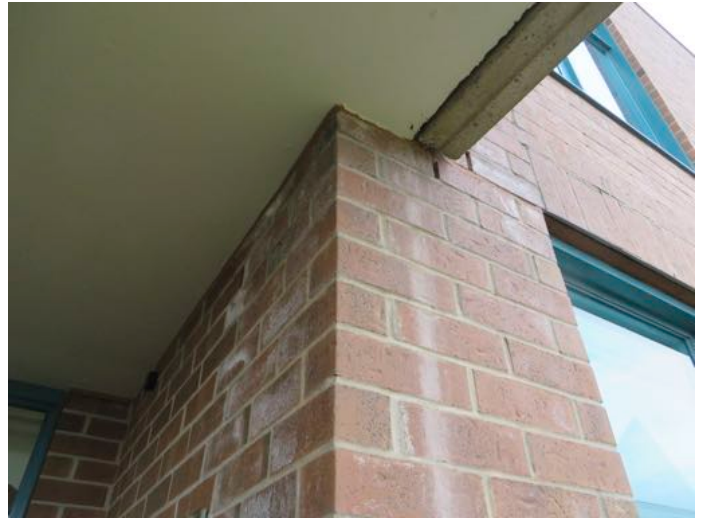
Photo 14

During the unit inspections, some brick efflorescence was observed at the balconies of Unit 1804 and two floors below (down to floor 16), as well as Units 1802 and 1402. At Unit 303 on the balcony area, it was observed that the brick mortar was in poor condition, and that the brick was dislodged. This should be repointed and corrected. At Unit 808 it appears that some mortar work was performed on the bricks at the balcony area; however, the mortar cleanup was poor and has stained some of the surrounding brick. The board noted similar conditions might be present in other units.

Example of brick efflorescence that was observed at the balcony of Unit 1804.

The brick veneer is in good condition. There are minor areas of efflorescence. These areas should be reviewed and monitored for worsening. Provided the caulking joints are maintained, the brick veneer should not require major repairs for many years. A cost for a large brick repair project has been included in this study.

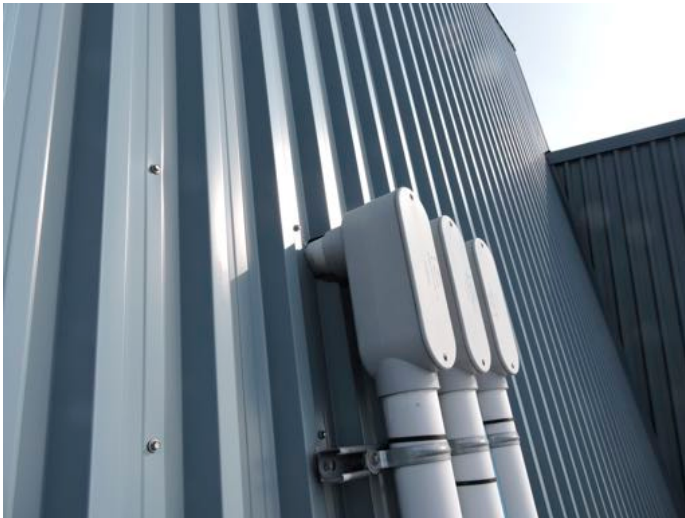
Photo 15

Caulking missing from penetrations at mechanical penthouse walls.

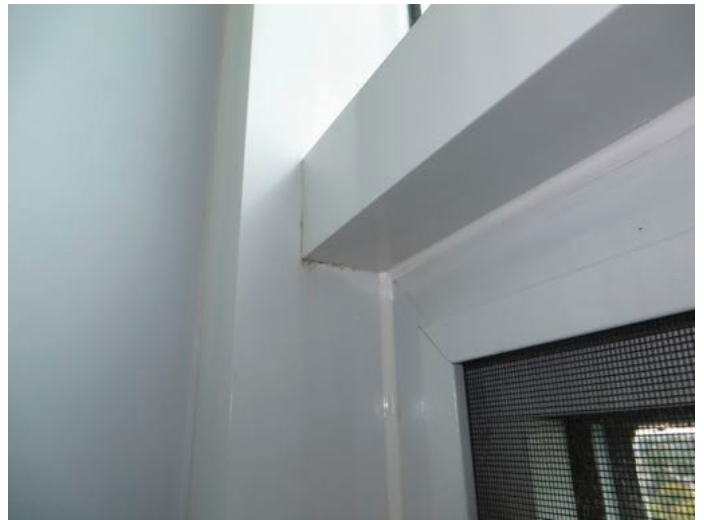
Photo 16

Example of water staining, observed at Unit 1402.

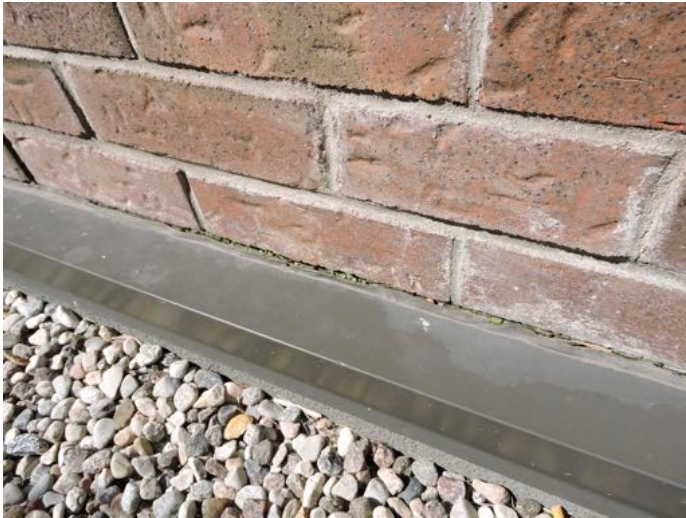
Photo 17

Example of deteriorated caulking outside of the subject property.

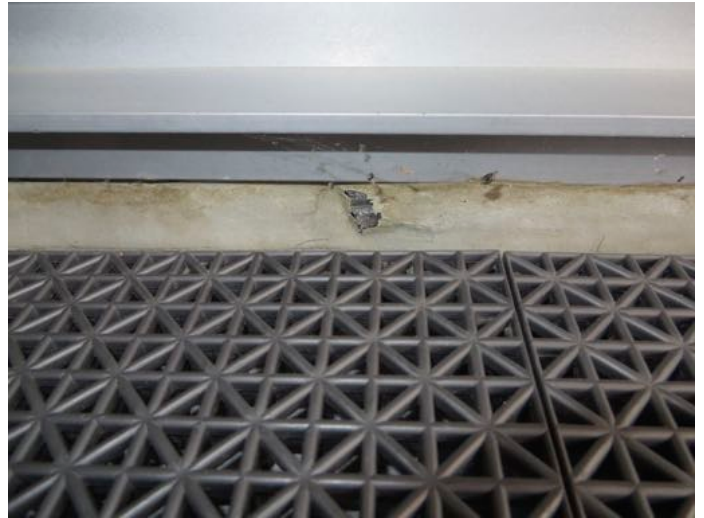
Photo 18

- Caulking near the balcony door appeared to be in poor condition at unit No. 1802 (missing, thin, and deteriorating). It appears as though some flashing was used in lieu of caulking, which is generally not recommended.
- At Unit 1402 some caulking has split, and is in poor condition.
- At Unit 1101, the exterior bedroom window caulking is in poor condition. As well, the flashing is sloped back.
- At Unit No. 1006, the dining room window caulking has deteriorated near the bottom of the operable window.
- At Unit No. 907 the caulking near the balcony door is fairly thin.

At Unit 1802, caulking deteriorating underneath a balcony door.

In general, the caulking is in fair condition and is approaching the end of its typical life expectancy. The few minor deficiencies noted above should be repaired using the operating budget. For large-scale replacements and repairs, the reserve fund should be used.

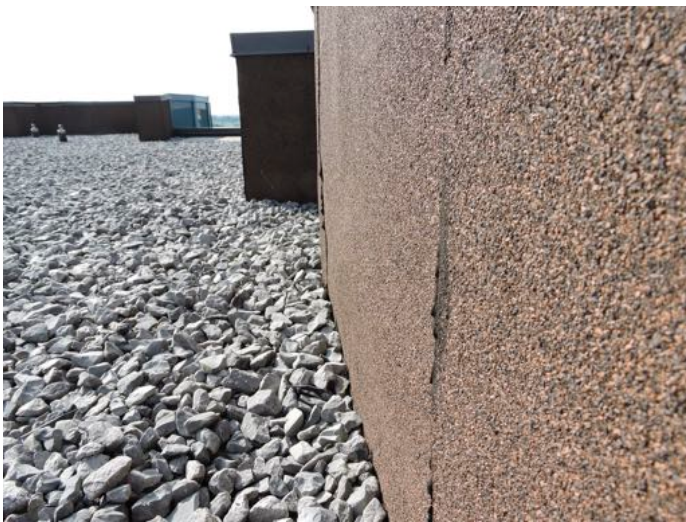
Photo 19

Parapet membrane is not adequately adhered.

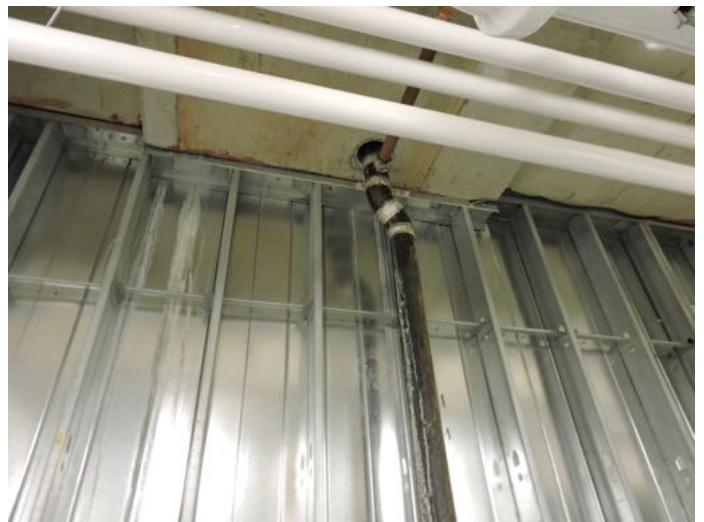
Photo 20

Example of staining on the mechanical penthouse metal walls.

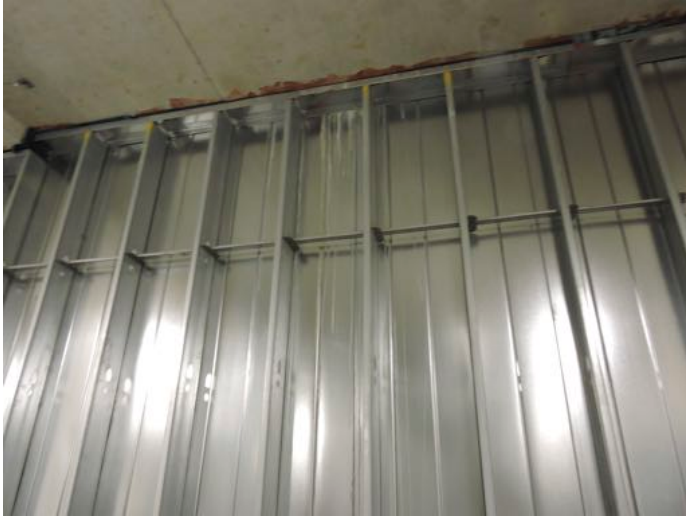
Photo 21

Another example of staining on the metal walls of the mechanical penthouse.

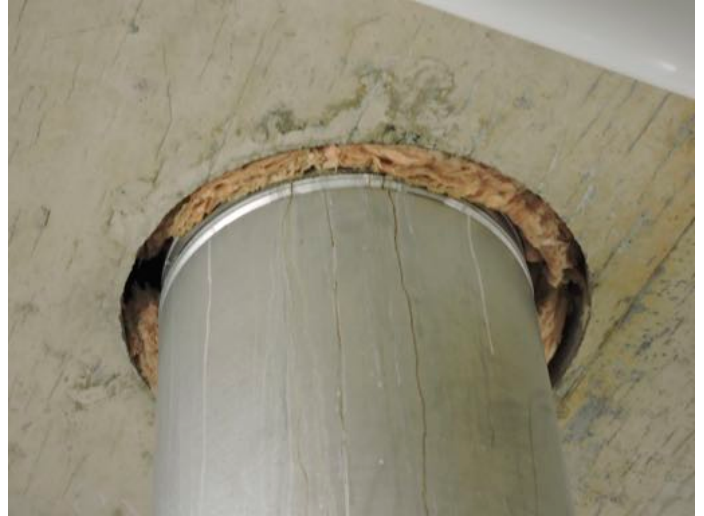
Photo 22

Exhaust stack from HW BOILER #1 appears to have leaks near the roof.

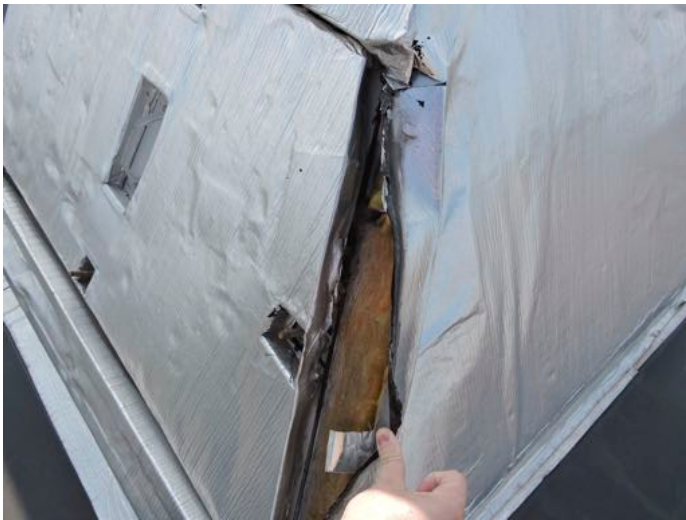
Photo 23

Reflective membrane on roof top chiller is poorly attached.
