COMPREHENSIVE RESERVE FUND STUDY

*Carleton Condominium
Corporations No. 667 and No. 769
Riverside Gate Shared Facilities*

Final Report

BLP File No. 7302.03
October 29, 2012

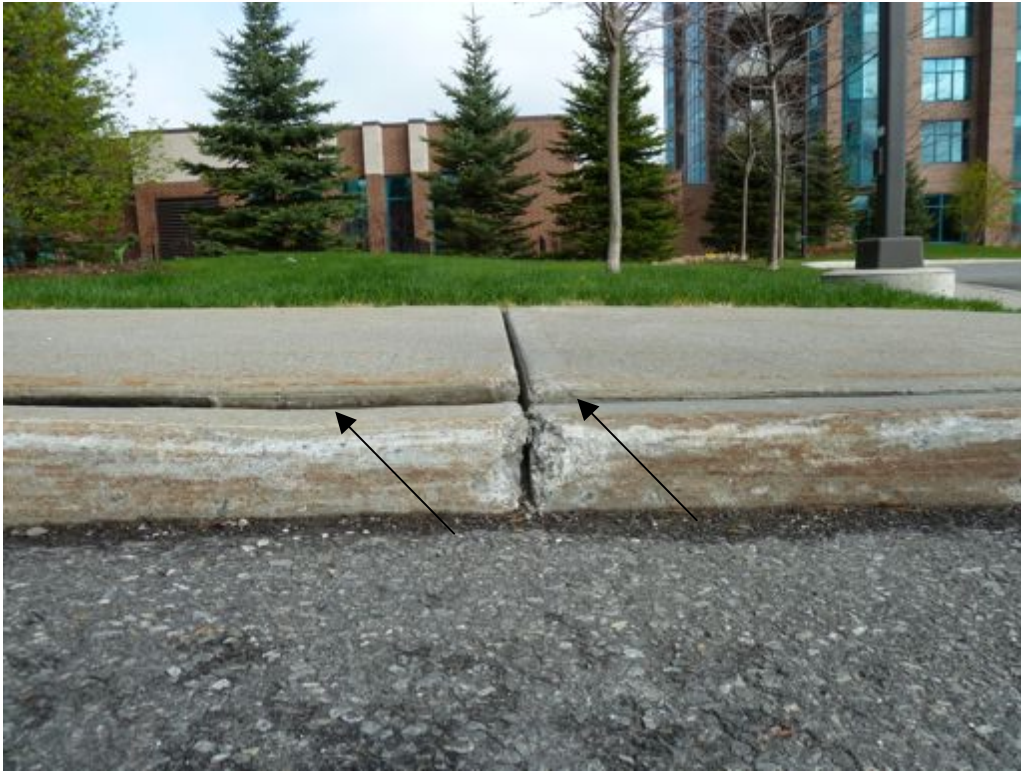
Cast-in-place concrete walkways are installed along the front of the building and the roadway. The concrete walkways are generally in good condition, however there is an elevation difference between the walkway and curb along the roadway between OCSCC 667 and 769. The elevation different is a tripping hazard and should be addressed. Refer to Photo 3.

3. Elevation difference between concrete sidewalk and curb near OCSCC 667. This is a tripping hazard.

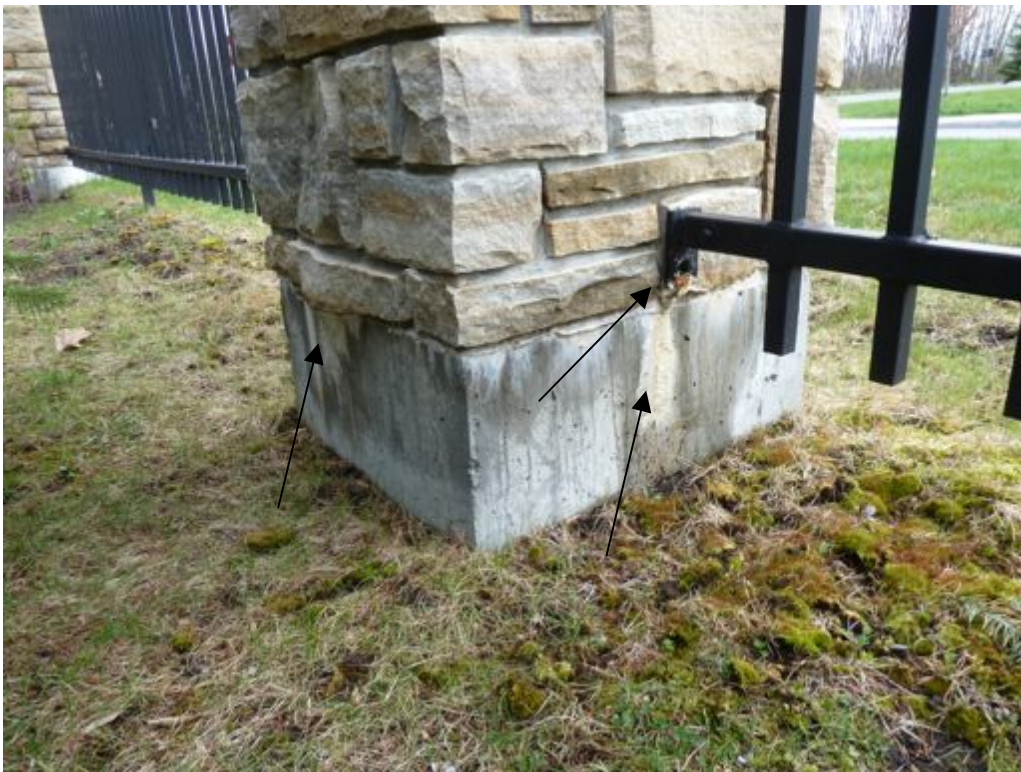
Masonry fence columns are located along the east side of the property. A decorative masonry wall is located at the main entrance near the gatehouse. The masonry columns and decorative wall are bearing on a concrete footing. The masonry fence columns are in fair condition, however efflorescence was observed on the masonry on numerous columns and along the bottom of the decorative wall. Refer to Photo 4. The efflorescence should be monitored over time for worsening. Repairs to the masonry units and re-point will likely be required over the course of the fence column's life. A contingency to repair the columns and wall is included in this study.

Painted steel fencing is installed along the east perimeter of the property, between the masonry fence columns. Steel fencing is also installed at the southeast corner of the shared pool building to close in a patio area. The steel fencing is generally in good condition, however the paint is peeling in several locations. Some corrosion has begun at several locations as well. Repairs and painting should be done using funds from the operating budget. Provided preventative maintenance is carried out over the life of the steel fencing, it should not require replacement during the 30-year duration of this study.

4. Typical masonry fence column. Note the efflorescence at the bottom of the masonry. Also note the steel fencing is corroding at various locations.

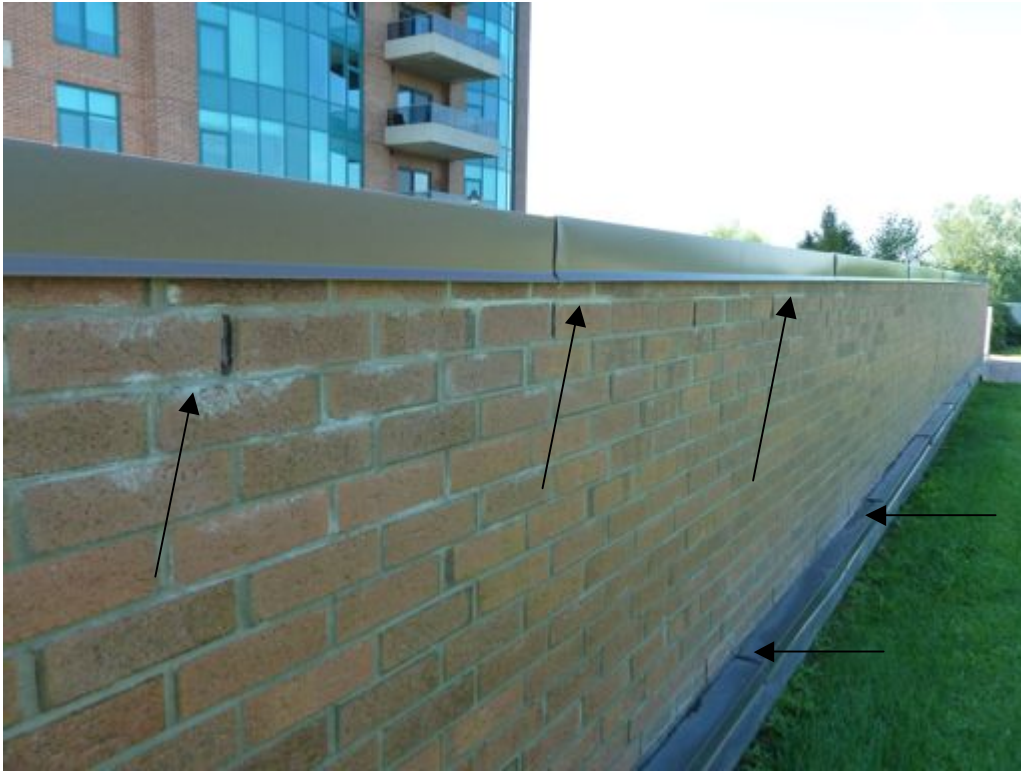
The brick veneer is in good condition. Efflorescence was observed at several locations around the shared pool building, which is a sign of water penetration behind the brick veneer.

- Some minor efflorescence was observed at the corner of the patio area between the shared pool building and OCSCC 667.
- Efflorescence was also observed on the brick veneer near the concrete walkway link near OCSCC 667 (west side of the shared pool building).
- Along the top and bottom of the brick wall on the north side of the building. Refer to Photo 5.

5. Efflorescence on the masonry veneer on the north wall of the Shared pool building. Also note the negatively sloped flashing at the base of the wall.

Provided the caulking joints, roofing, and flashing are maintained, the brick veneer should not require major repairs for many years. A contingency has been carried for occasional repairs to the brick veneer.

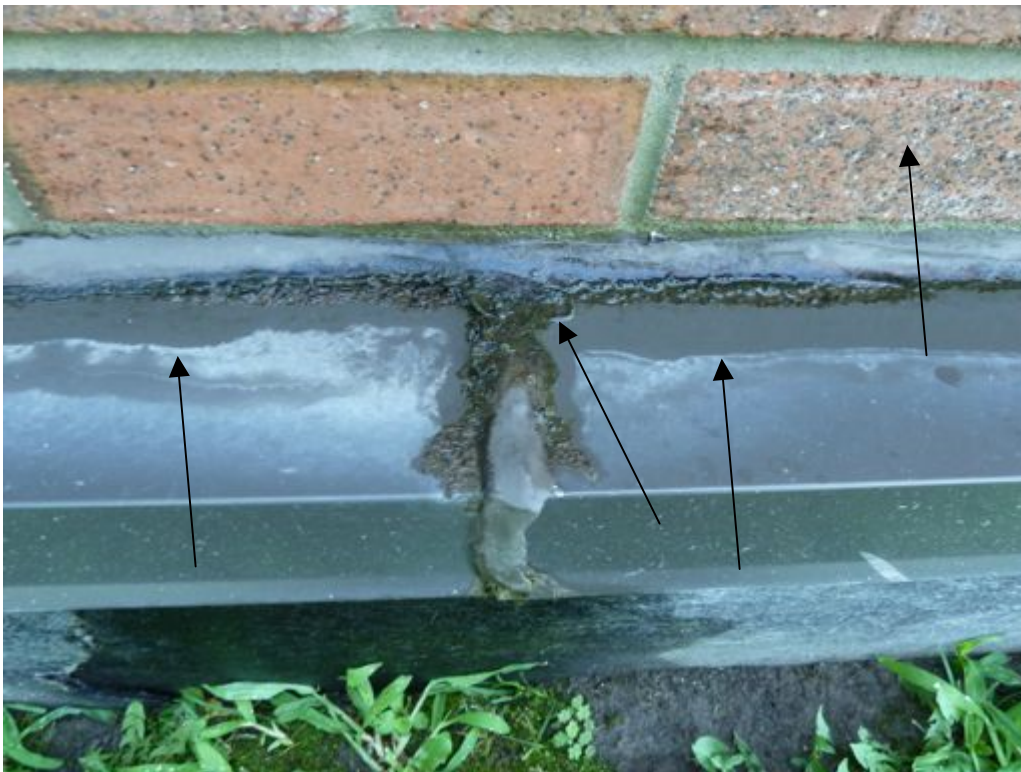
Pre-finished metal flashing is installed along the top of the parapet wall around the perimeter of the main roof and along the west end of the small roof. Metal flashing is also installed along the bottom of the north brick wall to protect the transition from the podium deck membrane to the air and vapour barrier behind the brick veneer. The metal flashing along the bottom of the north brick wall is sloping back and allowing water to pool on the metal flashing. In some locations, efflorescence was observed, indicate water I penetrating behind the brick veneer and not being able to properly drain out of the weep holes. In other locations, the caulking joint between the flashing and brick is deteriorating. Refer to Photo 6.

6. Negatively sloped flashing along the north brick veneer wall of the Shared pool building. Also note there is efflorescence on the brick and the caulking joint is deteriorated.

A contingency to repair the main and small roofs has been included in this study. The metal flashing detail along the north side of the shared building, and the deficiencies with the small lower roof should be repaired using this contingency.
