RESERVE FUND STUDY UPDATE WITH SITE VISIT
OTTAWA-CARLETON STANDARD CONDOMINIUM CORPORATION No. 769
OTTAWA, ONTARIO

File # 18377
March 12, 2019

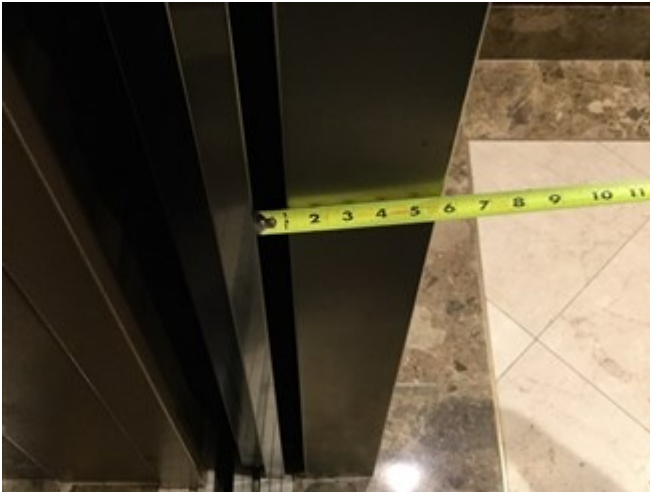
Photo - 1

#	Elevator	Description	Photo
1	1	The gap between car door and return is large. Adjust the elevator door and reduce gap to prevent any passenger injuries or pinching hazards. Return /swing panel is loose. Can be moved to enlarge door gap.	1
2	2	The hall door is not self-closing in the absence of an elevator. Adjust or replace the door close equipment to allow the door to close under its own force. At P level, when fully open door does not self close.
